Appendix-2: System of Inspection and Diagnosis for Port Structures Using an Unmanned Boat

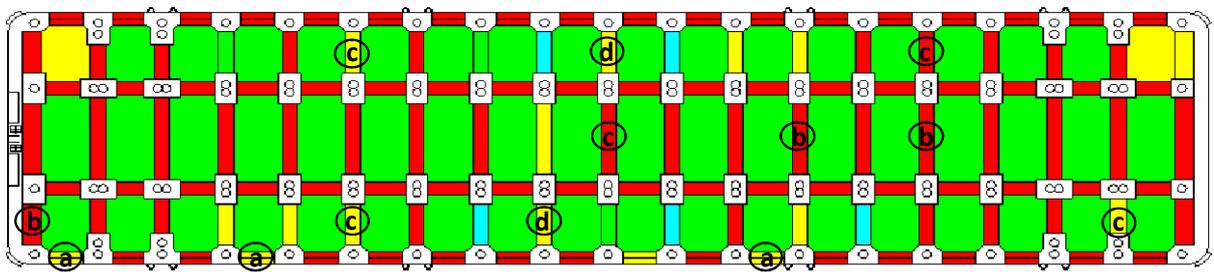
Figure 9 Degree of degradation determination (View from below)

The field trial test was carried out in an unloading piled pier constructed 45 years ago, which has 80 m in length and 20 m in width, as shown in Figure 6. The results are compared and verified with the human inspection system. As shown in Figure 7, the unmanned boat was operated to shoot the entire lower part of the piled pier. As a result, it was possible to finish taking pictures of about 1,600 m² in 2 hours. It was found to be improved 2.5 times over the standard inspection method by humans in Japan. Additionally, the 3D model of the entire lower part under the piled pier was created by means of 2,064 images (8,290,000 pixels). The created 3D model is shown in Figure 8. Also, the result from the method of automatically determining the degree of degradation was compared to the method of judgment by humans. Finally, a better coincidence is shown in Figure 9, 100% (54 members / 54 members) for the slab and 90% (116 members / 129 members) for the beam.

The alphabet in the circle is different from the visual inspection by a person
