Appendix-2: System of Inspection and Diagnosis for Port Structures Using an Unmanned Boat

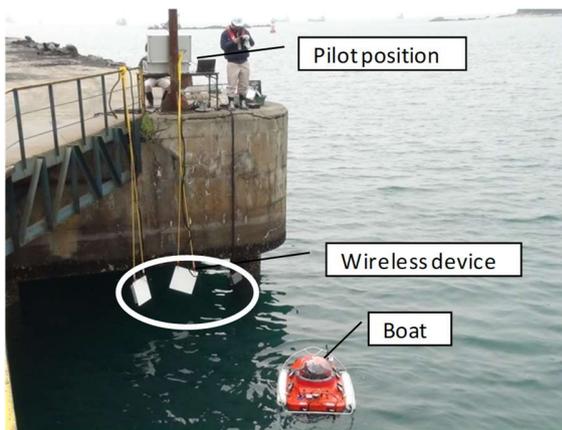
Figure 6 Inspection of the piled pier

The field trial test was carried out in an unloading piled pier constructed 45 years ago, which has 80 m in length and 20 m in width, as shown in Figure 6. The results are compared and verified with the human inspection system. As shown in Figure 7, the unmanned boat was operated to shoot the entire lower part of the piled pier. As a result, it was possible to finish taking pictures of about 1,600 m² in 2 hours. It was found to be improved 2.5 times over the standard inspection method by humans in Japan. Additionally, the 3D model of the entire lower part under the piled pier was created by means of 2,064 images (8,290,000 pixels). The created 3D model is shown in Figure 8. Also, the result from the method of automatically determining the degree of degradation was compared to the method of judgment by humans. Finally, a better coincidence is shown in Figure 9, 100% (54 members / 54 members) for the slab and 90% (116 members / 129 members) for the beam.
